# **A Nonlinear ultrasonic SHM method for impact damage localisation in composite panels using a sparse array of piezoelectric PZT transducers**

**Keywords:** Composite materials, Structural health monitoring, Damage localisation, Nonlinear ultrasound

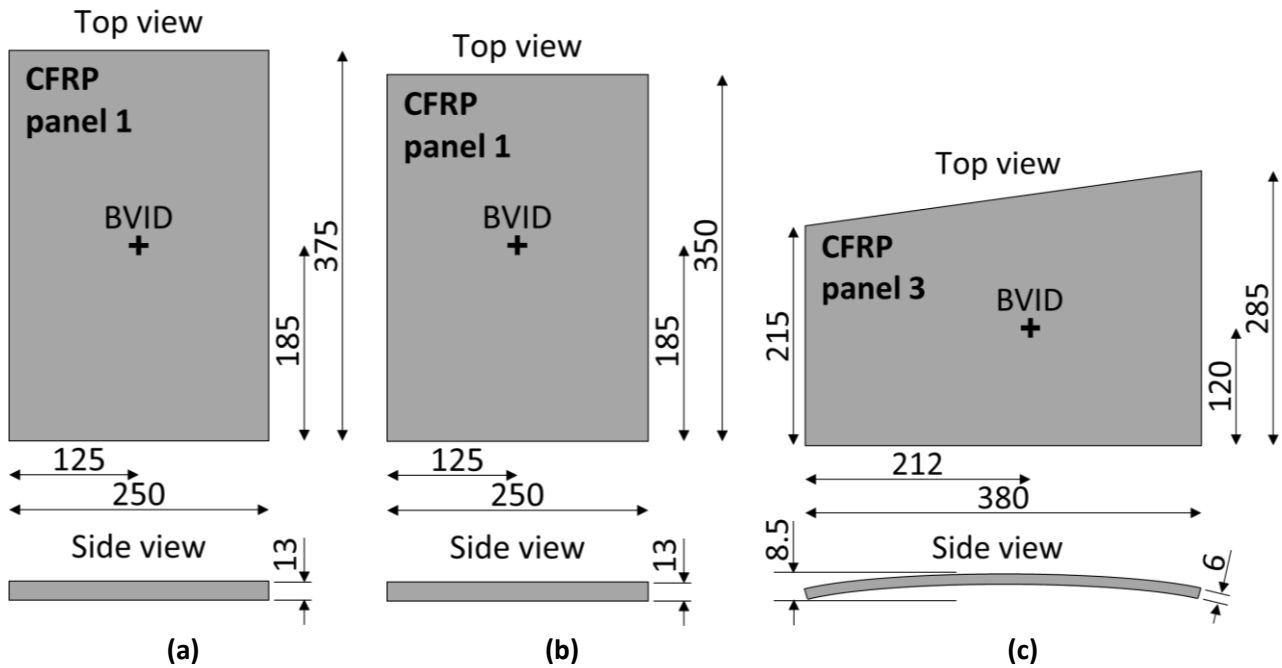
**Figure 3:** Illustration of CFRP panel 1 (a), 2 (b) and 3 (c) - Dimensions in mm. Not to scale.

The method explained in the previous section, was experimentally tested on three different CFRP panels of unknown lay-up and prepreg type, with BVID from unknown impact object and energy level. As shown in Figure 3, panels 1 and 2 were flat and rectangular (~13 mm thick), whereas panel 3 was trapezoid (~6 mm thick) and slightly curved in the direction of its long axis.

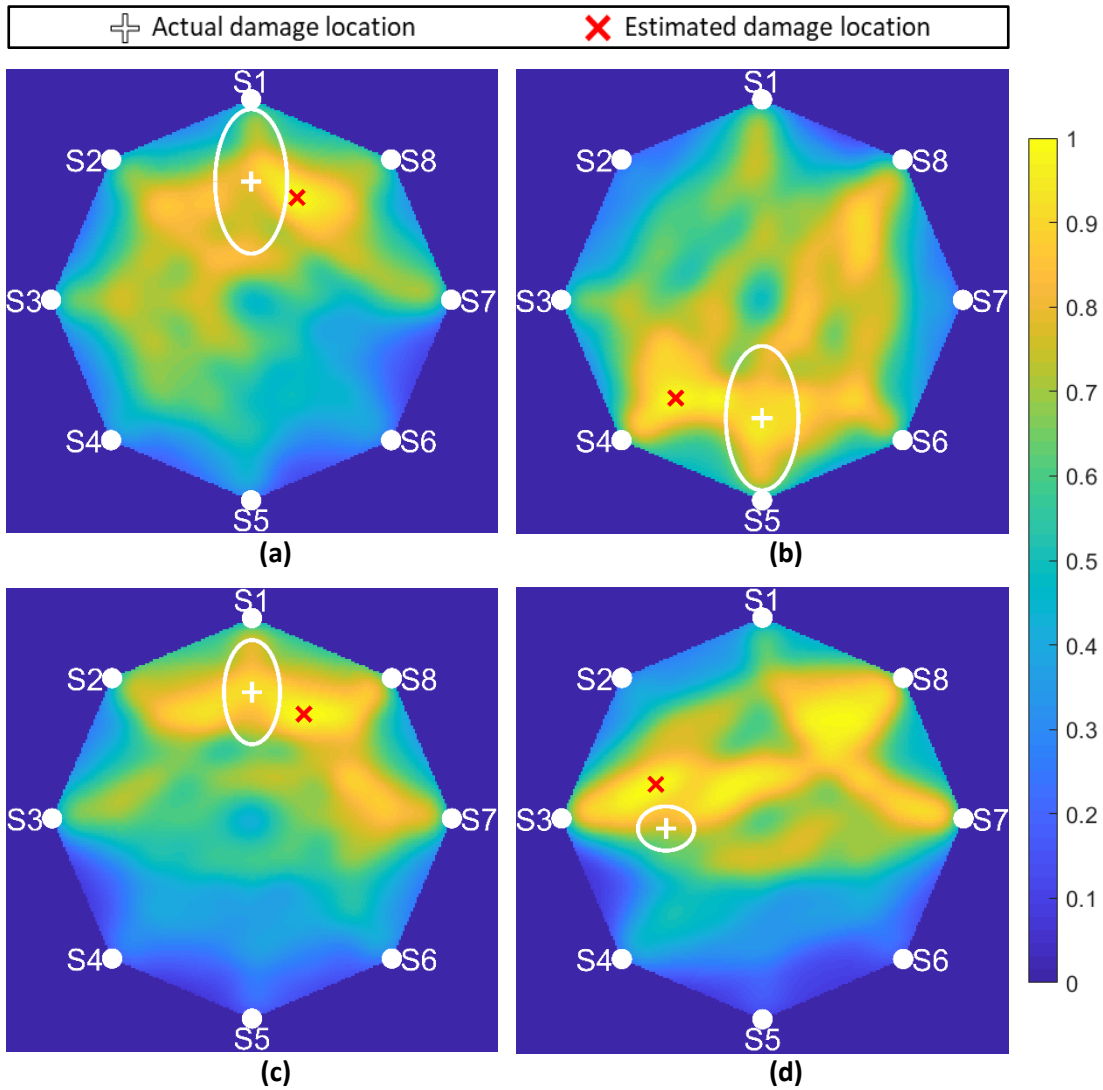
**Figure 10:** Normalised map of nonlinear parameter  $\beta$  in CFRP panel 1 - array position 1 (a), panel 1 - array position 2 (b), panel 2 (c) and panel 3 (d). The ellipses represent the actual size of internal delamination.

About the damage localisation results, in CFRP laminate 1 the determined value of  $f_S$  related to the highest signal amplitude was found to be 280 kHz for sensor array position 1, and 237.1 kHz for position 2. In panels 2 and 3,  $f_S$  was 357.9 kHz and 341.9 kHz respectively. After performing ultrasonic wave transmission at  $f_S$  (ref. Section 3.2), the normalised map of nonlinear parameter  $\beta$  on CFRP panel 1 was plotted for each sensor array position (1 and 2), as illustrated in Figure 10a and Figure 10b. The analogous maps of  $\beta$  for panels 2 and 3 were presented in Figure 10c and Figure 10d. In Figure 11, the same maps were plotted after applying a threshold from 0.99 to 1, for better illustration of the peak values of  $\beta$ . According to these maps, the BVID was successfully located in all different cases within an error range of 4 to 22 mm (average of  $\sim 12$  mm). It must be noted that the localisation error was measured from the estimated damage location to the boundary of BVID. If the error was measured from the centre of impact, the corresponding range would be 23 to 43mm. However, this would not be sensible because stronger acoustic nonlinearities may arise from specific areas (e.g. bigger delamination areas) within the damaged region, and not necessarily from the centre of impact. In fact, the C-scans provided in Figure 4 indicated that the areas of bigger delamination were off-centred, and in most cases, they were close to the estimated damage position.
